1997-1999 GREEN BAY METROPOLITAN AREA
INTERSECTION CRASH STUDY

Adopted by the Brown County Planning Commission Board of Directors
February 7, 2001

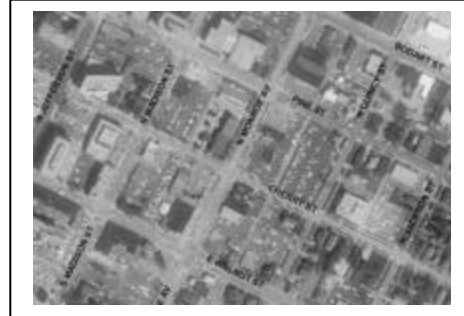
1. Madison Street/Cherry Street (Green Bay)

Comments: Despite the relatively low number of reportable crashes, the intersection of Madison Street and Cherry Street had one of the highest crash rates in the metropolitan area between 1997 and 1999 because of its relatively low daily traffic volume. The data for this intersection suggest that nearly all of the crashes are right angles that are usually caused by northbound (Madison) motorists disregarding the traffic light and that most of the crashes result in only property damage. The disregard for the traffic control is likely a result of motorists trying to beat the red light at this intersection to travel from Walnut Street to Pine or Main without stopping.

Recommendations: The number of crashes at the Madison/Cherry intersection would probably decrease significantly if Madison were narrowed and converted to a two directional facility because opposing traffic and increased side friction would slow the Madison motorists down and make them less likely to try to beat the light. Converting Cherry to a two directional street appears to have reduced vehicle speeds and conflicts with intersecting traffic, so this should be considered for Madison as well.

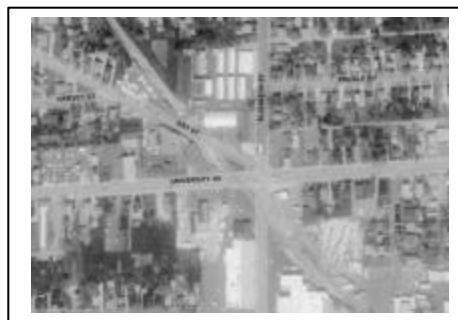
Comments: The most common (and severe) incidents at this intersection were angle crashes that occurred on University Avenue when eastbound and westbound motorists turned left in front of oncoming vehicles. The intersection also experienced several rear end crashes that appear to have been caused by slippery streets and drivers that were not paying attention (especially during the weekday afternoons).

Recommendations: Since a left turning motorist's inability to see oncoming traffic appears to be the cause of nearly 40 percent of the crashes at this intersection, the signals regulate traffic relatively inefficiently because of the intersection's fifth leg (Day Street), and approaching motorists apparently have trouble paying attention and traveling at appropriate speeds during poor weather, the intersection could be made much safer and more efficient if the signals were replaced with a five leg roundabout. However, if this is not feasible due to space constraints, many of the crashes could be eliminated by constructing offset left turn lanes that allow motorists making left turns to easily see vehicles approaching in the opposing through lanes. The offset lanes are illustrated in Figure 1 at the end of the report.

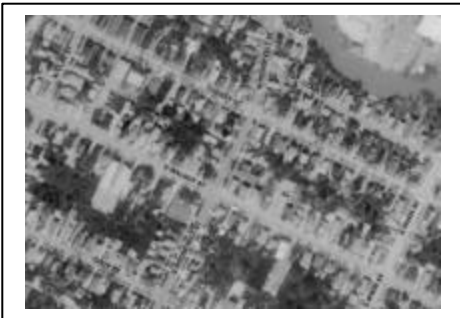
Comments: At first glance, it appears that the likelihood of being injured during a crash at this intersection is relatively great because of the high number of injuries. However, removing the twelve injuries that occurred during three alcohol-related crashes reduces this number significantly. These incidents aside, the most common crashes at the intersection were angle crashes that occurred when northbound (Roosevelt) motorists pulled out in front of eastbound and westbound motorists on Walnut. Also, the vast majority of the crashes at this intersection happened between 1:00 and 5:00 on weekday afternoons.

It is possible that some of these crashes happened due to visibility problems caused by trees at the intersection’s southwest corner or vehicles waiting to turn right in the northbound right turn lane. These visibility problems could have caused motorists to guess when adequate gaps were present, quickly accelerate into small gaps in the heavy weekday afternoon flow, and get hit before reaching the other side.

Recommendations: It is possible that some of the crashes could be eliminated by removing the right turn lane at Roosevelt’s northbound approach and possibly removing a tree at the southwest corner to improve visibility, but these changes will not address the other issues at the intersection. A single lane roundabout, however, would address the visibility and traffic control issues at the intersection, eliminate most of the crashes and nearly all of the injuries, and even minimize the damage that could be caused by future alcohol-related crashes. Since the number of vehicles entering the intersection each day is likely below 10,000, a single lane roundabout could easily handle the traffic load. A roundabout would certainly enhance safety, make the area more pedestrian and bicycle friendly, and improve the area’s appearance without compromising traffic flow on Walnut Street.

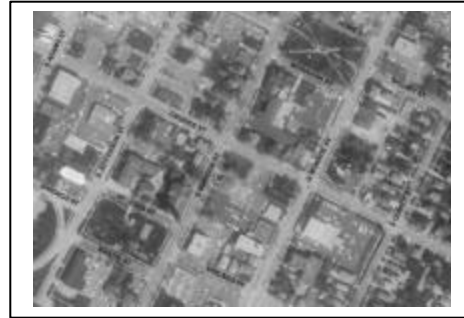
Comments: According to the data for this intersection, almost every reportable crash occurred at a right angle while both vehicles were driving straight and was caused by a vehicle on Crooks pulling into the path of a vehicle traveling north on Madison. Since the intersection is very wide and vehicles are able to travel relatively fast on Madison, it is likely that most (if not all) of the crashes were the result of vehicles being unable to get across the intersection before encountering an oncoming vehicle in one of Madison Street's many travel lanes.

Recommendations: Madison Street should be converted to a two-way street and narrowed to minimize the distance drivers, pedestrians, and bicyclists have to cross and to encourage drivers on Madison to travel through the area at slower speeds. Since Crooks is a popular means of traveling between Monroe Avenue and Washington Street, the city should also consider placing a roundabout at the intersection to make it safer, more efficient, and more attractive.

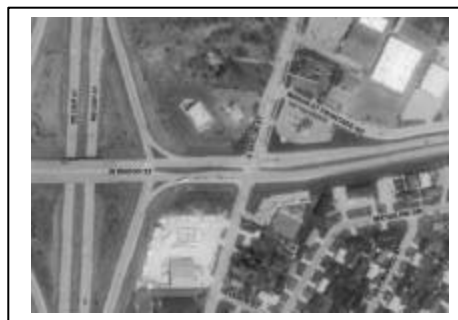
Comments: The most common (and severe) incidents at this intersection were angle crashes that occurred on Mason Street when eastbound and westbound motorists turned left in front of oncoming vehicles and when Mason motorists disregarded the traffic signal and hit northbound and southbound Taylor motorists.

It is difficult to determine why motorists disregard the signals so frequently, but it is likely that many drivers try to avoid being stopped at the intersection but fail to beat the red light and that some westbound motorists are ignoring the Taylor lights as they concentrate on positioning themselves to enter US 41. The crashes caused by left turning vehicles pulling in front of vehicles traveling straight are probably due to the inability of left turners to see traffic approaching from the opposite direction because their view is obstructed by opposing left turners. This situation appears to be common at many of the intersections in this study and, in this case, should be relatively easy to correct.

Recommendations: The problems addressed above could be corrected with a roundabout at the Mason/Taylor intersection, and this roundabout would be even more effective if roundabouts were built at the two Mason/US 41 ramp intersections to the west. A roundabout at Mason and Taylor would also make the intersection much safer for pedestrians and bicyclists, improve the attractiveness of the area, and would quickly pay for itself by significantly reducing property damage and injuries. However, if a roundabout is not feasible, a more immediate method of solving the left turning problems would be to construct offset left turn lanes in the Mason Street medians to enable motorists to easily see oncoming vehicles (see Figure 1).

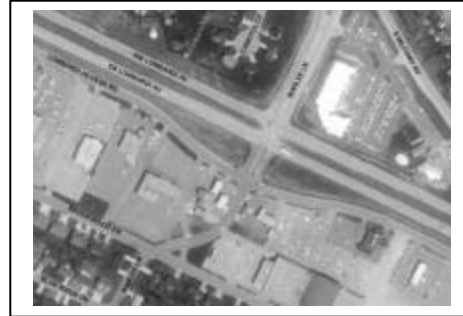
Comments: The most common incidents at this intersection were angle crashes that occurred when motorists traveling in all four directions turned left in front of oncoming vehicles and eastbound rear end crashes that were almost entirely caused by inattentive driving and poor weather conditions. Like at many of the other intersections in this study, it is likely that the left turn crashes at Lombardi/Marlee were caused by the inability of left turning motorists to see oncoming vehicles before making their turns. The rear end crashes are more difficult to explain, but the extremely high proportion of eastbound crashes (many of which occurred on weekday afternoons) suggests that people are continuing to drive fast after exiting US 41 and are suddenly encountering vehicles stacked at the Marlee signal.

Recommendations: A relatively low cost method of making left turns safer on Lombardi Avenue would be to construct offset left turn lanes in the Lombardi medians to enable motorists to easily see oncoming vehicles (see Figure 1). Many of the rear end crashes could also be eliminated by encouraging eastbound Lombardi motorists to drive slower by narrowing each of the street's four lanes to eleven feet and curbing the outside of the street to make it feel less like a highway and more like a city street.

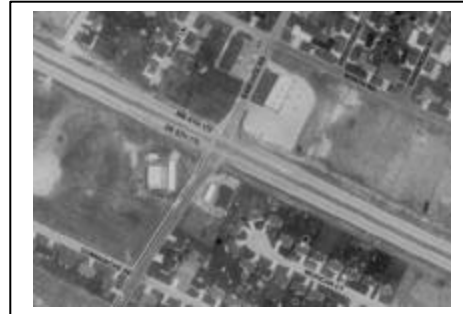
Comments: The most common (and severe) incidents at this intersection during the three year period were angle crashes that happened when vehicles traveling straight hit vehicles making left turns, and most of these crashes and nearly all of the injuries occurred on STH 172. Most of the crashes happened during the weekday afternoon and morning peak travel periods.

Recommendations: A relatively low cost method of making left turns safer on STH 172 would be to construct offset left turn lanes in the STH 172 medians to enable motorists to easily see oncoming vehicles (see Figure 1). Another option that would significantly reduce conflicts at the STH 172/Babcock intersection would be to construct a roundabout. A roundabout would address all of the safety problems at the intersection, increase traffic flow and capacity, make the intersection more pedestrian and bicycle friendly, and improve the area's appearance.

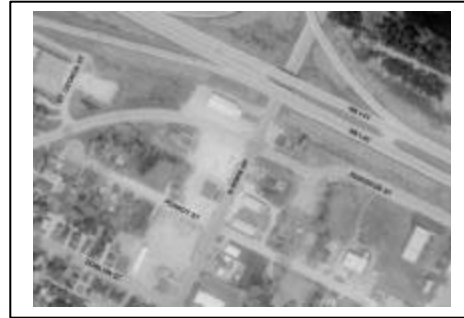
Comments: Until May of 1999, the Irwin/Radisson intersection was controlled by stop signs at the Radisson approaches. Judging by the data for the intersection, many of the crashes were caused by vehicles on Radisson pulling into the path of vehicles traveling north and south on Irwin. Since the intersection is relatively wide, vehicles were able to travel reasonably fast on Irwin, and many of the vehicles involved in the crashes were trucks, it is likely that most of these crashes were the result of trucks being unable to enter or cross the intersection in time to avoid collisions. Even though two rear end crashes occurred at the new Irwin stop signs in 1999, the conversion of the intersection to a four way stop appears to have reduced the total number of right angle crashes from six in 1998 to one in 1999.

Recommendations: The four way stop seems to have improved traffic safety at the intersection, but the city should monitor the intersection to determine if the number of crashes continues to remain low.

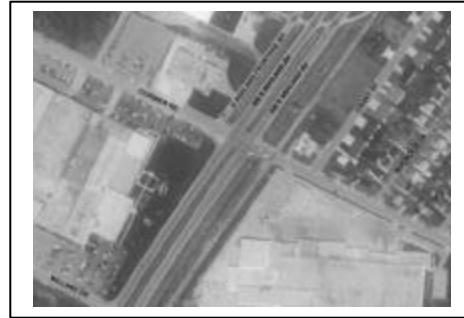
Comments: The most common (and severe) incidents at this intersection during the three year study period were angle crashes that happened when vehicles traveling straight hit vehicles making left turns, and most of these crashes occurred when a southbound left turner pulled in front of a northbound vehicle. The left turn crashes were responsible for 18 of the intersection's 36 injuries between 1997 and 1999.

The next most common crash appears to have been motorists hitting fixed objects at the intersection. Of the twelve fixed object crashes recorded at the intersection, eight were collisions with traffic signals that did not involve alcohol or poor driving conditions, and six of the traffic signal crashes were caused by northbound drivers making right turns. This is not surprising, for the signal and a utility pole at this corner are located virtually on the curb.

Recommendations: Many of the crashes and injuries at the intersection would likely be eliminated by constructing offset left turn lanes in the existing Ashland Avenue medians (see Figure 1). This project should be relatively inexpensive because adequate space exists between the northbound and southbound lanes, and the money saved by reducing crashes and injuries at the intersection would pay for the improvements in very little time. The traffic signal and utility pole at the intersection's southeast corner should also be moved back several feet to eliminate these hazards.

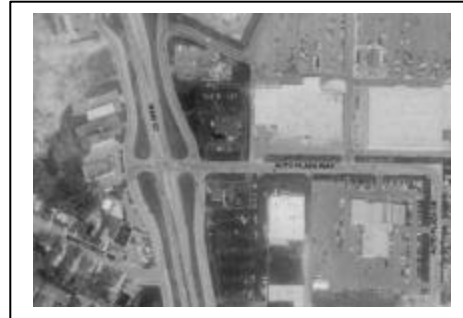
Comments: The most common incidents at this intersection were angle crashes that occurred when vehicles on the east Main Street frontage road pulled out in front of vehicles traveling east or west on Auto Plaza Way. In almost every instance, the Main frontage road vehicles appeared to have been trying to cross Auto Plaza Way to reach the opposing frontage road. These crashes were likely a result of the frontage road motorists trying to cross several lanes of fast moving traffic on Auto Plaza Way by quickly accelerating into what were believed to be adequate gaps and getting hit before reaching the other side of the street.

Recommendations: The data suggest that more than a third of the crashes at the Main/Auto Plaza Way intersection could be eliminated if motorists approaching Auto Plaza Way on the east frontage road were only allowed to make right turns. Left turns onto the frontage road from Auto Plaza Way could still be allowed since they do not appear to cause many crashes, but frontage road motorists that want to turn left or go straight would be forced to use the other streets to the north and south. This issue is discussed further in the Conclusions section of the study.

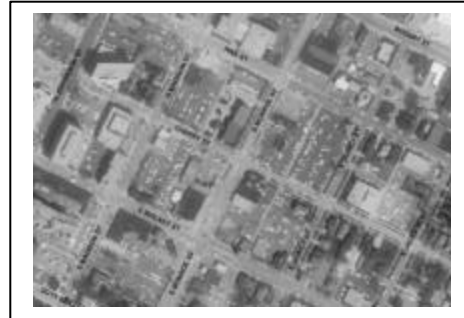
Comments: The most common incidents at this intersection were angle crashes that happened when both vehicles were traveling straight, and the vast majority of these incidents were caused by southbound Monroe drivers running the red light and hitting eastbound vehicles on Cherry. Since all of the vehicle crashes during this period occurred when Cherry was a one way street, a typical crash was probably one that happened when a southbound motorist tried to beat the red light, wound up running it, and hit an eastbound motorist as the motorist was accelerating into the intersection as soon as the light turned green (which was common when Cherry was a one way street). The high speeds on Monroe, rapid acceleration of vehicles from Cherry, and proximity of the southbound and eastbound vehicles at the intersection left motorists very little time to avoid the crashes.

Recommendations: The intersection should be monitored for the next three years to determine if the Cherry Street traffic pattern change has made the intersection safer.

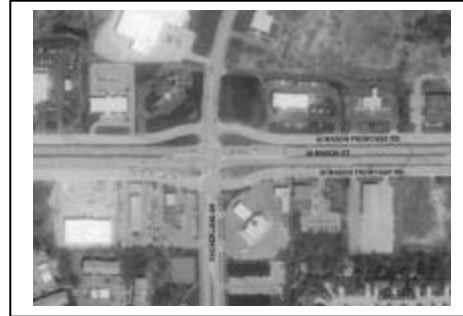
Comments: The most common incidents at this intersection were angle crashes that occurred when vehicles on the West Mason frontage roads pulled out in front of vehicles traveling north or south on Packerland Drive. In almost every instance, the West Mason frontage road vehicle was attempting to make a left turn onto Packerland or was trying to cross Packerland to reach the opposing frontage road. These crashes were likely the result of the frontage road motorists trying to cross several lanes of fast moving traffic on Packerland by quickly accelerating into what were believed to be adequate gaps and getting hit before entering the flow or reaching the other side of the street.

Recommendations: The data suggest that over half of the crashes at the West Mason/Packerland intersection could be eliminated if motorists entering Packerland Drive from the frontage roads were only allowed to make right turns. Left turns onto the frontage roads from Packerland could still be allowed since they do not appear to cause many crashes, but frontage road motorists that want to turn left or go straight should be forced to use the other streets to the east and west. A possible negative impact of this action, however, is that motorists on the east frontage road might cut through the Grand Central Station parking lot to reach Packerland Drive. This temptation could possibly be lessened by reducing the size of the gas station's driveways, but some cutting through would still likely occur. These issues are discussed further in the Conclusions section of the study.

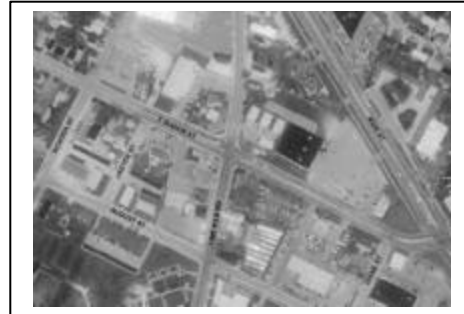
Comments: The most common incidents at this intersection were angle crashes that occurred when motorists traveling in all four directions turned left in front of oncoming vehicles. Rear end crashes were also fairly common, and all but one of these crashes occurred at the eastbound and northbound approaches. Also, alcohol was a factor in 21 percent of the crashes and 33 percent of the injuries during the three year study period. The high number of alcohol-related crashes at the intersection could be related to the high concentration of taverns in the area.

Recommendations: The city should stagger the left turning vehicles so approaching vehicles can be seen well before reaching the intersection (see Figure 1). On Lime Kiln, this could be accomplished by restricting the two inside lanes of Lime Kiln to left turns and forcing all through and right movements to occur in the two outside lanes. The most recent WisDOT counts for Lime Kiln indicated that traffic volumes on the street's north and south legs were below 13,000 vehicles per day, so the inside lanes could be devoted to left turns without seriously compromising the street's capacity. Methods of reducing the number of intoxicated drivers leaving area taverns should also be explored to further reduce the likelihood of crashes at the intersection.

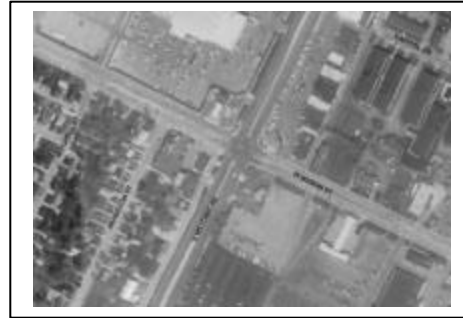
Comments: The most common incidents at the West Mason/Military intersection were rear end crashes that resulted from motorists following too closely and driving inattentively. The rear end crashes also resulted in more than half of the injuries at the intersection and were evenly distributed between the eastbound, westbound, and northbound approaches. Since many of these crashes occurred on Mason Street during the weekday peak travel periods, it is possible that they were caused by motorists concentrating on making it through the lights at Fisk and Mitchell and not stopping fast enough to avoid the long queues at Military that are suddenly created by traffic spilling onto Mason from the many driveways. It is also possible that many of the Mason crashes resulted from motorists accelerating when the Military light turned green and having to suddenly decelerate when the light turned red again.

Recommendations: To slow motorists down, reduce weaving, and minimize driver confusion on Military, the city should consider narrowing the street to four lanes between 9th Street and Dousman Street. The 1998 counts for this segment of Military indicated that daily traffic volumes did not exceed 19,000 at any count station, and four lanes can easily handle this amount of traffic. The extra space at the Mason intersection could then be used to create offset left turn lanes that would enable left turning motorists to see oncoming vehicles

To improve safety on Mason Street, the city should consider constructing offset left turn lanes like the ones recommended for Military and other intersections in the study. The city should also attempt to reduce the number of conflicts along Mason Street by working with the merchants along Mason between Fisk Street and Mitchell Street to develop shared driveways.

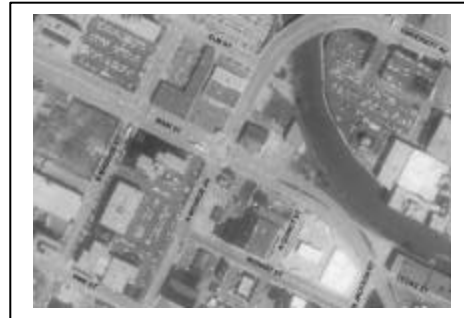
Comments: Many of the incidents at this intersection were caused by Main Street motorists disregarding the traffic controls, but the rest resulted from several different driver errors. The planned narrowing of Main Street might reduce vehicle speeds on Main and make drivers more reluctant to try to beat the traffic light at Monroe. The narrowing project will also provide an opportunity to create offset left turn lanes on Main to enable motorists to easily see oncoming vehicles (see Figure 1).

Recommendations: When Main is narrowed, the city should construct offset left turn lanes to maximize traffic visibility for left turning motorists. The island created by the offset lanes should also be large enough to serve as a pedestrian refuge.

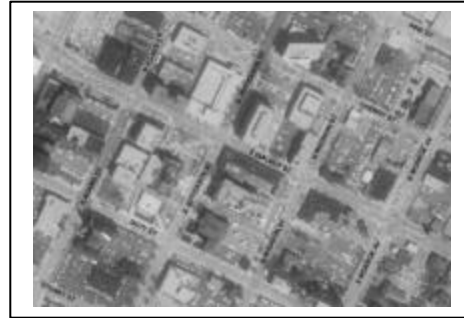
Comments: The most common incidents at this intersection were angle crashes that occurred when motorists on Walnut Street disregarded the traffic signal and hit motorists traveling south on Jefferson Street. All of the rear end crashes recorded at the intersection during the three year period also occurred on Walnut Street. The three pedestrian and bicycle crashes appear to have been caused by people walking and bicycling against the signal.

Recommendations: Since the reduction of crashes at the Cherry/Monroe intersection probably has a lot to do with Cherry Street's conversion to a two way street, it is recommended that Jefferson Street be slightly narrowed and converted to a two way street as well. In addition to encouraging vehicles to enter the intersection more slowly because of the presence of opposing traffic, the narrowing and conversion to two directional traffic will improve downtown circulation and make the intersection easier for pedestrians to negotiate.

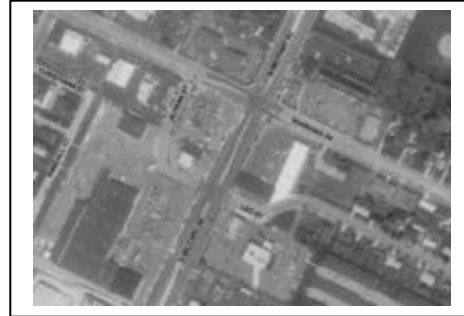
Comments: The most common incidents at this intersection were angle crashes that occurred when northbound and southbound motorists on Military Avenue disregarded the traffic signal and hit eastbound and westbound Leo motorists, and most of the Military violators were traveling north prior to the crashes. These crashes likely occurred because the traffic signals at the Leo intersection are dim, the signals are difficult to identify (the mast arms barely extend over Military Avenue's outside lanes), speeds on Military are relatively high, and many motorists on Military do not expect to encounter a set of signals so close to the Shawano Avenue intersection.

Recommendations: The city should increase the visibility of the Leo Street signals by extending the mast arms farther over the northbound and southbound Military Avenue lanes and replacing the dim signals with new ones that are easily seen. The city should also narrow Military Avenue between 9th and Dousman for the reasons identified in the West Mason/Military intersection recommendations.

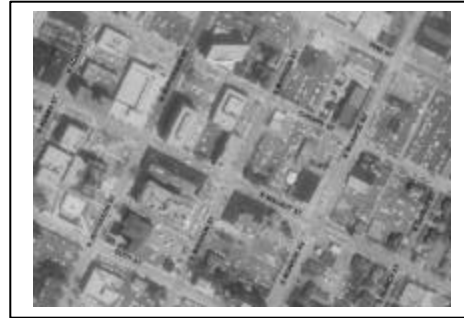
Comments: The most common (and severe) incidents at this intersection were angle crashes that occurred when a motorist disregarded the traffic signal. The distribution of these violations was fairly even, but more of these crashes were caused by eastbound motorists than by motorists from the other two approaches. The next most severe incidents over the three year period were angle crashes that were caused by motorists driving the wrong way (southbound) on Madison Street. There were also a few rear end crashes at the intersection between 1997 and 1999.

Recommendations: The number of crashes at the intersection would probably decrease if Madison were narrowed and converted to a two directional facility because opposing traffic and increased side friction would likely slow the Madison motorists down, encourage them to enter Walnut Street more cautiously, and make them less likely to try to beat the light. The crashes caused by people driving the wrong way on Madison would also be eliminated if the street is converted to two directions.

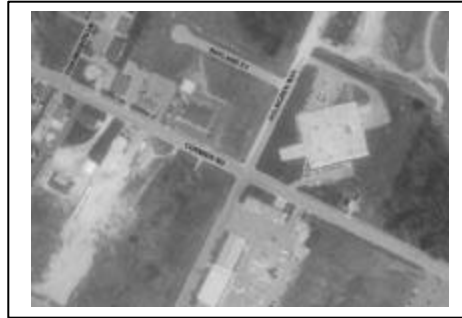
Comments: The number of crashes and injuries at the Cormier/Holmgren intersection was reduced after signals were installed at the beginning of 1998. The most common problem now appears to be collisions that occur when vehicles traveling straight hit vehicles making left turns.

Recommendations: The intersection should be monitored over the next few years to determine how the new signals have affected traffic safety.

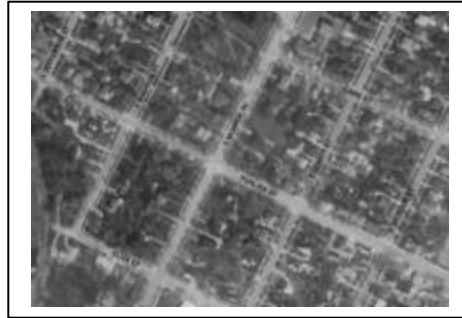
Comments: Most of the crashes at this intersection occurred when a northbound or southbound vehicle hit another vehicle as it was turning left onto Porlier. These crashes were likely the result of left turners not being able to see vehicles approaching the intersection in the outside lanes because an opposing vehicle was also waiting to make a left turn.

Recommendations: Assuming this was (and is) the problem, the ideal solution is to stagger the left turning vehicles so approaching vehicles can be seen well before reaching the intersection (see Figure 1). However, this could only be accomplished by restricting the two inside lanes of Monroe to left turns and forcing all through and right movements to occur in the two outside lanes.

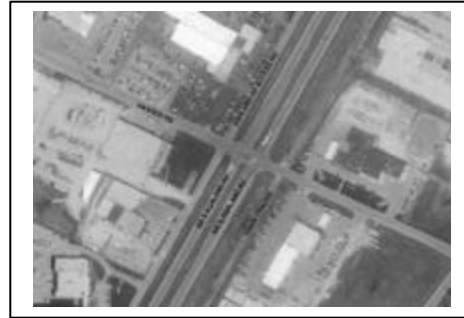
Comments: This intersection experienced several angle and rear end crashes that were caused by several different factors over the three year study period, but the most common incidents were angle crashes that occurred when left turning Ashland motorists were hit by motorists traveling north and south on Ashland. As was likely the case at many other intersections addressed in this study, these crashes were probably the result of left turners not being able to see vehicles approaching the intersection in the outside lanes because opposing vehicles were also waiting to make left turns.

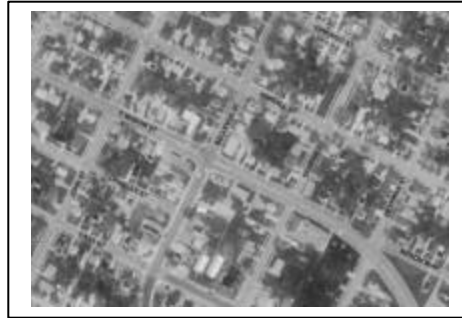
Comments: The East Mason/Bellevue intersection experienced a variety of different crashes during the three year study period, but the most common incident at this intersection was an angle crash that occurred on Mason Street when a left turning vehicle was hit by an oncoming vehicle. The intersection's rear end crashes occurred exclusively on Mason Street, and they were almost evenly distributed between the eastbound and westbound approaches. There were also seven crashes and nine injuries attributable to alcohol-related incidents at the intersection.

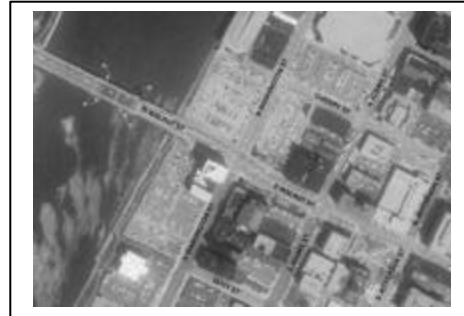
Comments: The most common (and severe) incidents at this intersection were rear end crashes that occurred when motorists on Walnut Street were driving inattentively or too fast during poor weather conditions. The data suggest that many of these crashes happened when motorists traveling east over the Walnut Street bridge were unable to stop before hitting vehicles stopped at the Washington Street light. Many of the crashes that happened during bad weather might have been a result of eastbound motorists skidding down the hill between the bridge and Washington Street.

Recommendations: Perhaps the city can post signs at the bridge's east and west approaches that warn drivers of possible queues and tell them to proceed with caution over the bridge (especially during bad weather).

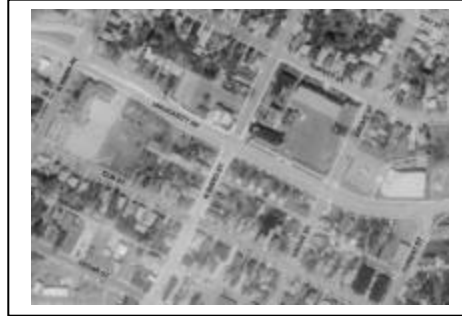
Comments: The most common incidents at this intersection were angle crashes that occurred on University Avenue when left turning vehicles were hit by oncoming vehicles. These crashes likely occurred because speeds on University are relatively high and it is difficult for left turning motorists to see approaching vehicles if an opposing vehicle is also waiting to make a left turn. The University/Baird intersection also experienced four alcohol-related crashes during the three year study period, and poor driving conditions appear to have contributed to some of the crashes.

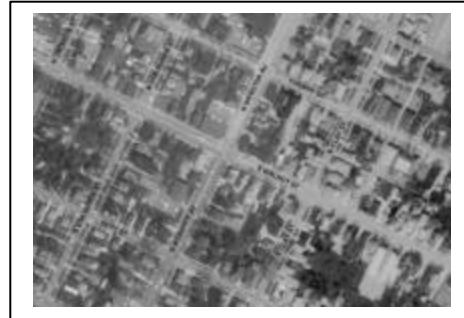
Comments: This intersection experienced a variety of crashes that were caused by a variety of factors between 1997 and 1999, but the most common (and severe) incidents were angle crashes caused by motorists disregarding the traffic signal at all four approaches. Although only one southbound motorist caused a crash by disregarding the signal, southbound motorists were responsible for all of the rear end crashes on Webster and for the majority of rear end crashes at the entire intersection during the three year study period. The intersection also experienced a relatively high number of crashes while the traffic signals were in flash mode, for four of the ten crashes that occurred between midnight and noon happened when the signals were flashing.

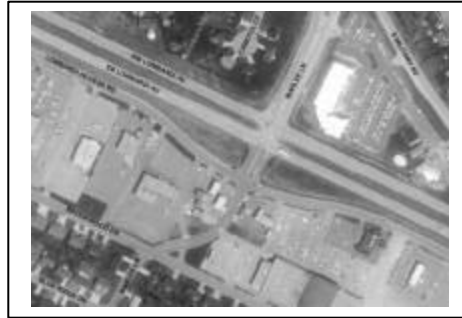
Comments: The most common incidents during the three year period were angle crashes that occurred when westbound frontage road vehicles tried to cross Marlee and were hit by vehicles traveling south through the Lombardi intersection. These and a few other types of crashes at the intersection suggest that it is very difficult for vehicles stopped at the south, east, and west approaches to accelerate through the wide intersection to avoid vehicles traveling through the green light at Lombardi.

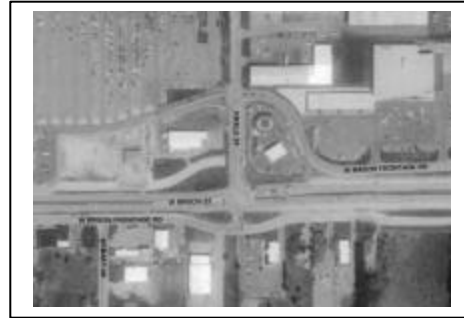
Comments: The most common incidents at this intersection were rear end crashes on Mason Street that occurred when motorists were driving inattentively or were following other motorists too closely. The intersection also experienced several left turning angle and side swipe crashes, and more than half of the crashes during the three year study period happened on a Friday, Saturday, or Sunday.

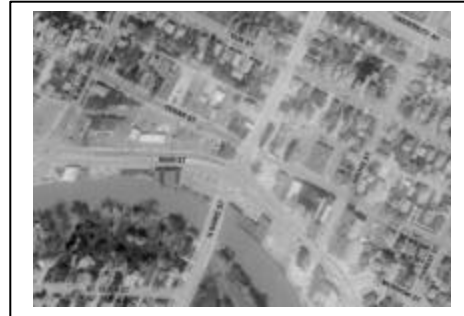
Comments: The most common incidents at this intersection during the three year period were angle crashes that happened when vehicles traveling straight hit vehicles making left turns, and nearly all of the left turners were traveling westbound or southbound when they were hit. Also, all of the motorists that were cited for disregarding the traffic signal on Main were traveling eastbound prior to the crashes.

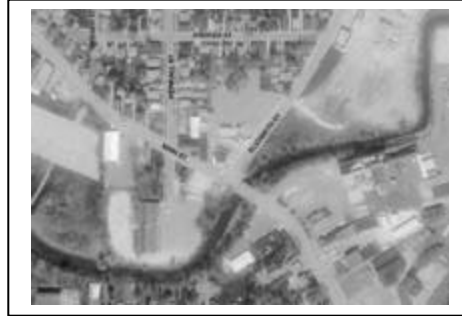
Comments: The most common incidents at this intersection were angle crashes that occurred when westbound motorists turned left in front of eastbound motorists and eastbound rear end crashes. There were also several alcohol-related crashes at or near the intersection, and more than half of the crashes happened on a Saturday or Sunday. However, all of the crashes occurred in 1997 and 1998, which suggests that the Main Street reconstruction project made the intersection much safer.

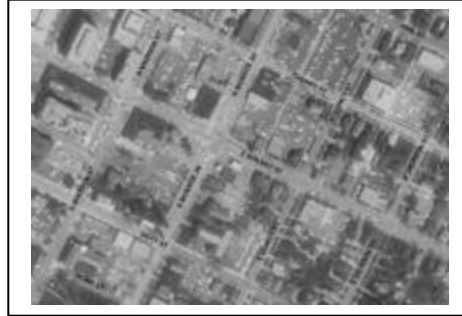
Comments: This intersection experienced a variety of crashes that were caused by a variety of factors between 1997 and 1999, but the most common incidents were angle and rear end crashes caused primarily by southbound and eastbound motorists that had failed to yield or were driving inattentively. The crashes were also fairly evenly distributed throughout the week and occurred at all times of the day.
